Spartan-3A Evaluation Kit Errata

These errata apply to Revision B of the kit, as noted in the Assembly part number on the backside of the board (SP3A-EVAL-ASY-**B**).

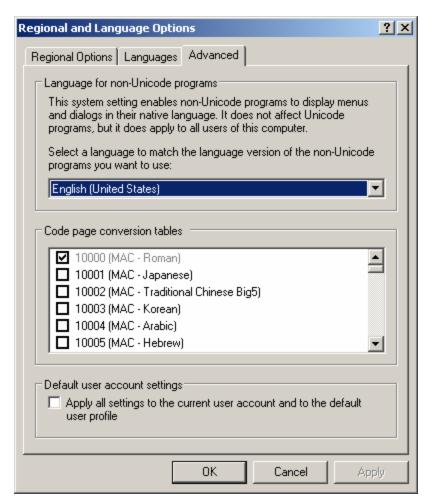
Figure 2 – Setting the Language for non-Unicode programs in Windows

Avnet Programming Utility Serial Communications Disrupted on non-English Language Computers

AvProg was designed using Microsoft Visual Basic v6.0. This version of VB creates applications that internally are non-Unicode. Windows XP and Windows Vista are both full Unicode operating systems. When AvProg runs in Windows, the non-Unicode characters are translated to Unicode characters as a function of the O/S. For English language computers, this is not an issue as the Unicode and non-Unicode characters are the same. However, for non-English computers, the non-Unicode characters are not the same as some Unicode characters.

This is an issue since AvProg relies on specific character strings to be sent to the Spartan-3A Evaluation board as commands. When the non-Unicode characters get translated to Unicode, the strings are corrupted, which in turn corrupts the commands and communication between computer and board.

To correct this problem, you must change the "Language for non-Unicode programs" on the host system to English. Follow the instructions below to do this on a Windows XP system:

- a. Launch the Control Panel from the Start Menu.
- b. Double-Click Regional and Language Options.
- c. Select the Advanced tab.
- d. Select **English** in the list box, as shown below.
- e. Click the **OK** button.
